ARCHAEOLOGICAL  
SERVICES  
DURHAM UNIVERSITY

Morpeth Leisure Centre  
Morpeth  
Northumberland

archaeological building recording

report 5136  
September 2019

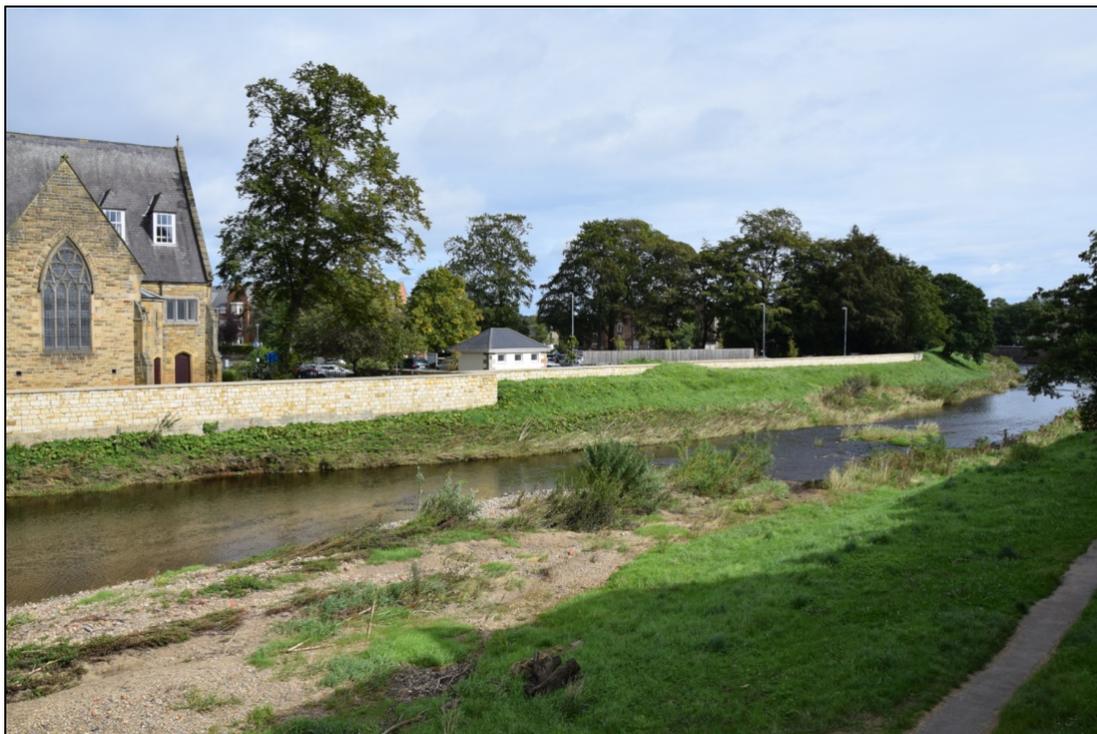
Photograph 1: The site seen from the south end of the Telford bridge. The brick wall of The Willows can just be seen between the trees, left of centre; modern flood banks hide the former gardens

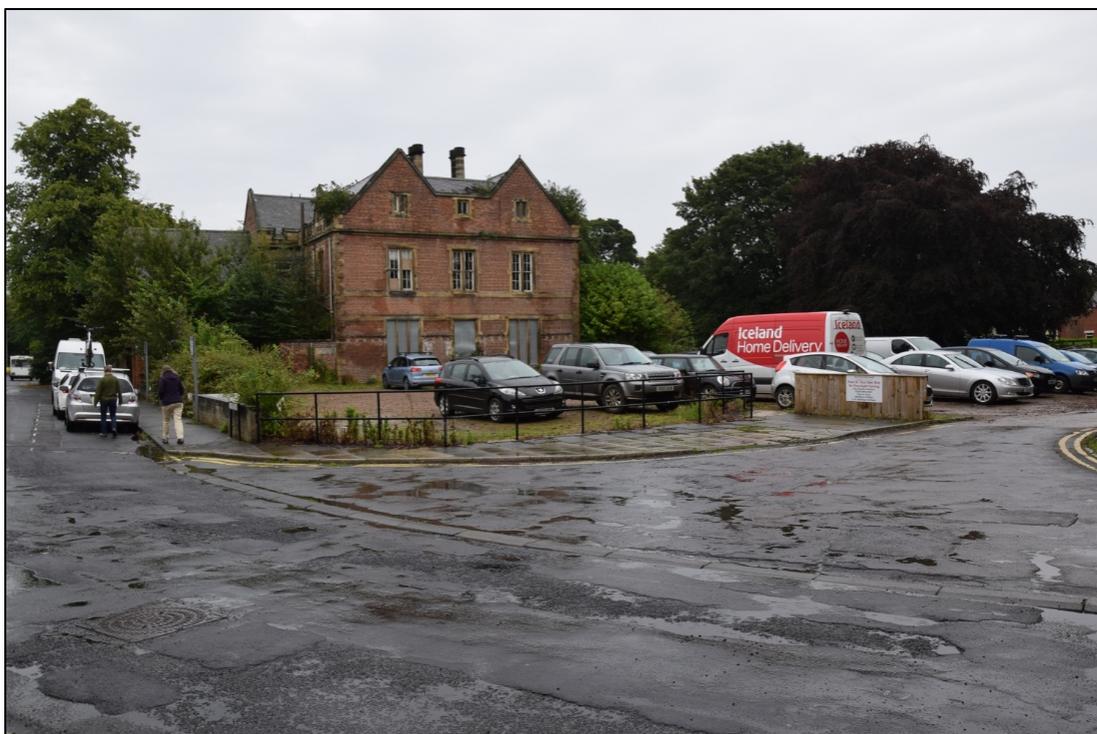
Photograph 2: The site seen from the end of Gas House Lane, before the trees were removed. The car park was formerly part of the garden of Beechfield, the house shown here

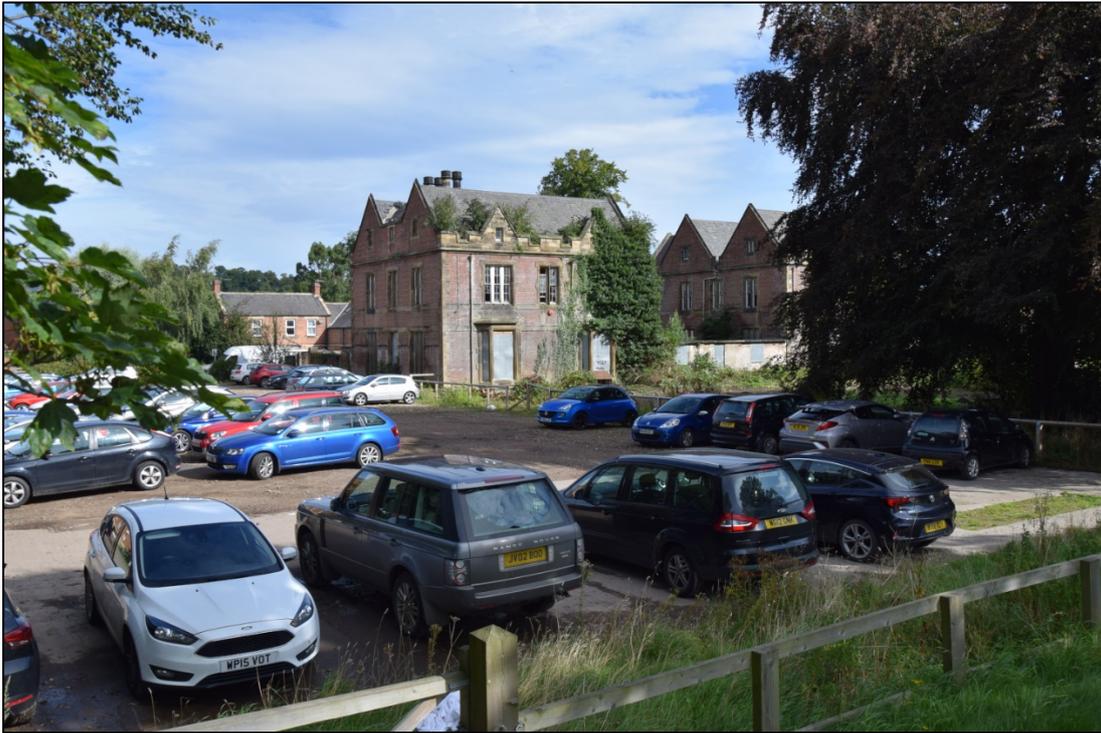
Photograph 3: The houses seen from the flood bank at the south-west corner of the former garden. Note the large old copper beech at the right. The small building left of the main block was the coach house and stable for The Willows

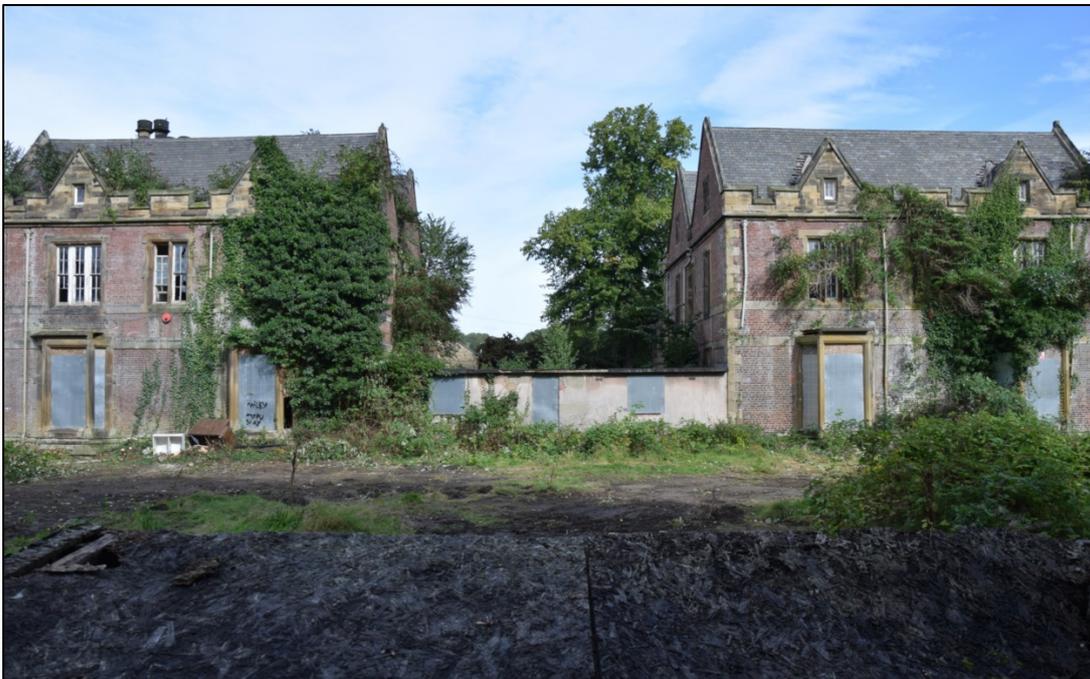
Photograph 4: The south face of the two houses, showing the courtyard cut off by the modern link corridor

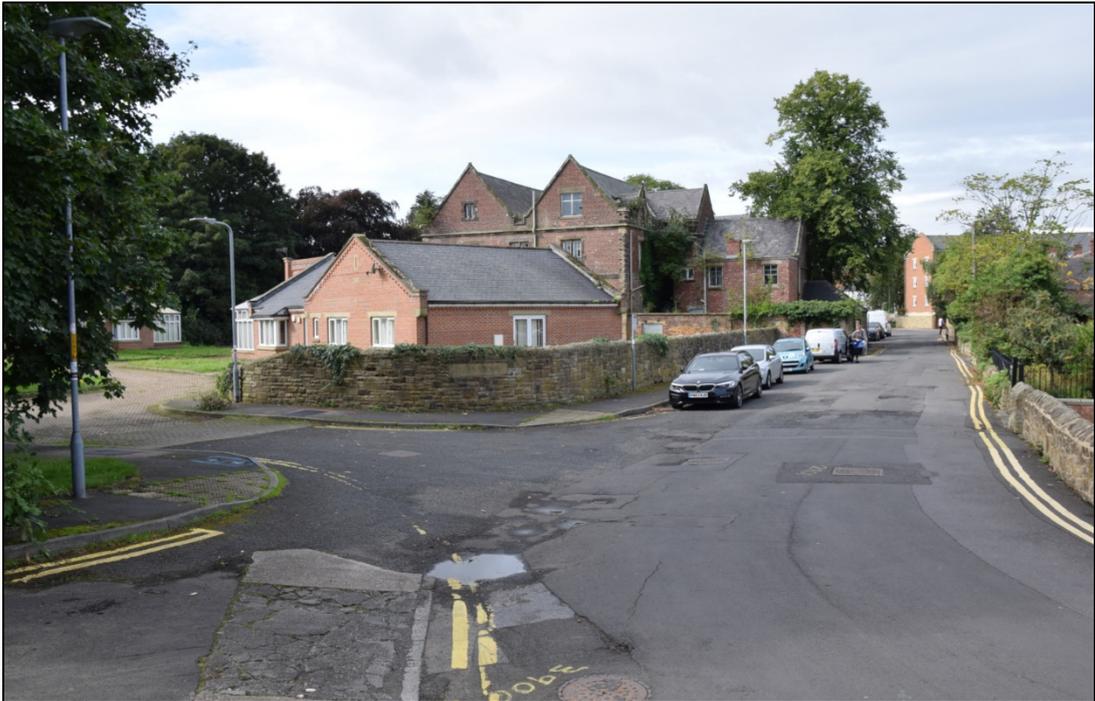
Photograph 5: The view from the north-east. The brick bungalows are on the site of the garden for The Willows

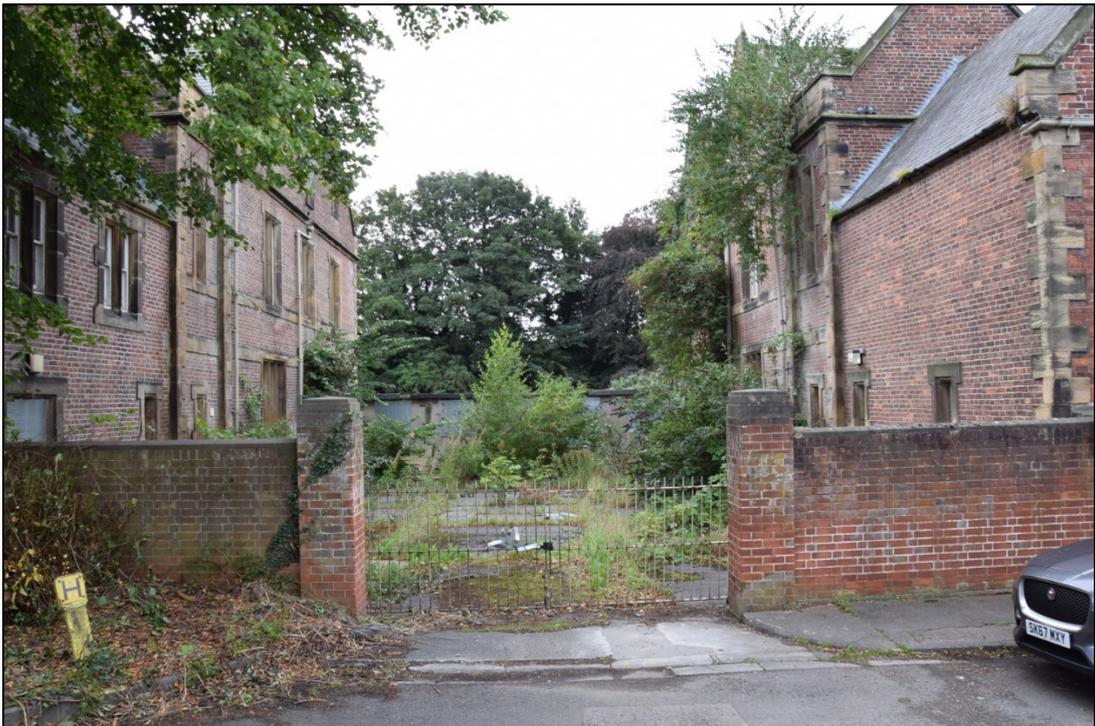
Photograph 6: The shared yard between the two houses. The wall is a 20th-century alteration. A view looking south

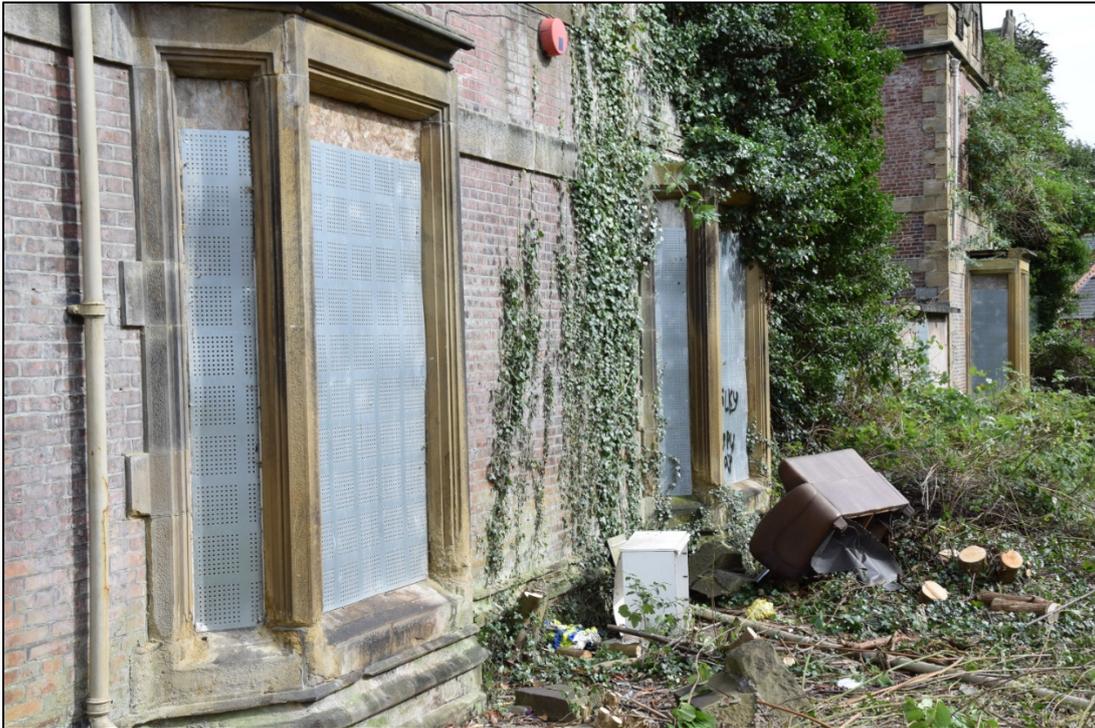
Photograph 7: The different depths of the south-facing bay windows can be seen here. A view looking north-east

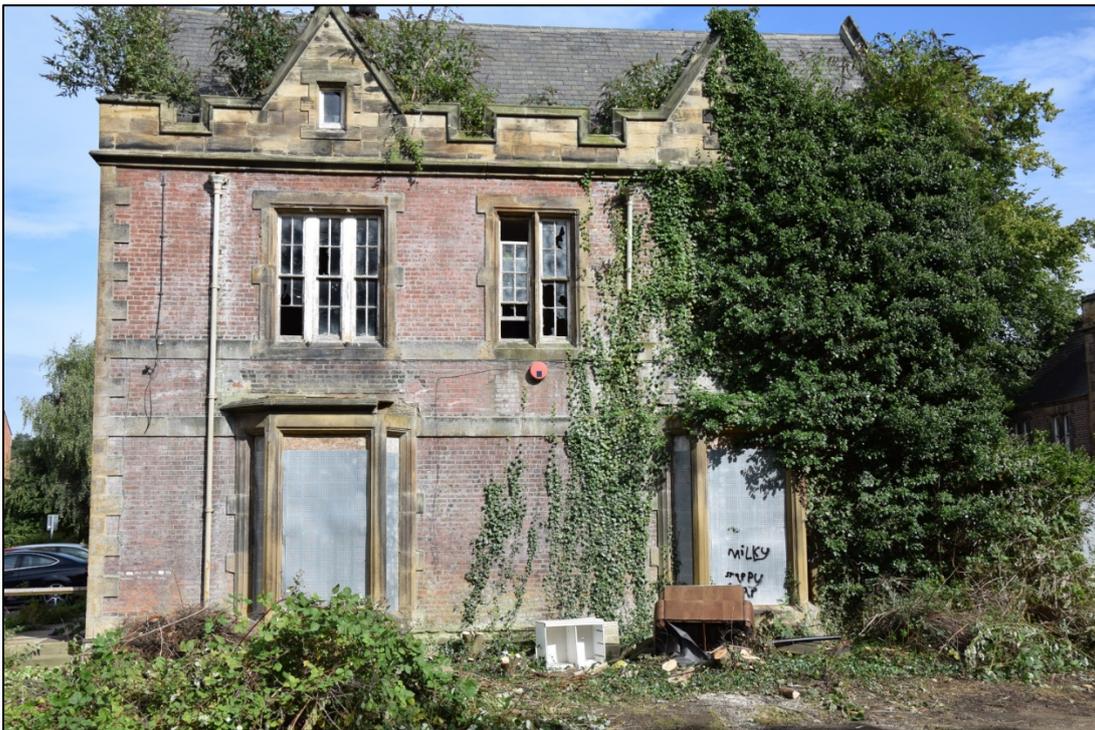
Photograph 8: The south face of Beechfield. One light of the right-hand bay window is open; this allowed a limited view of the interior, shown in Photos 19 and 20

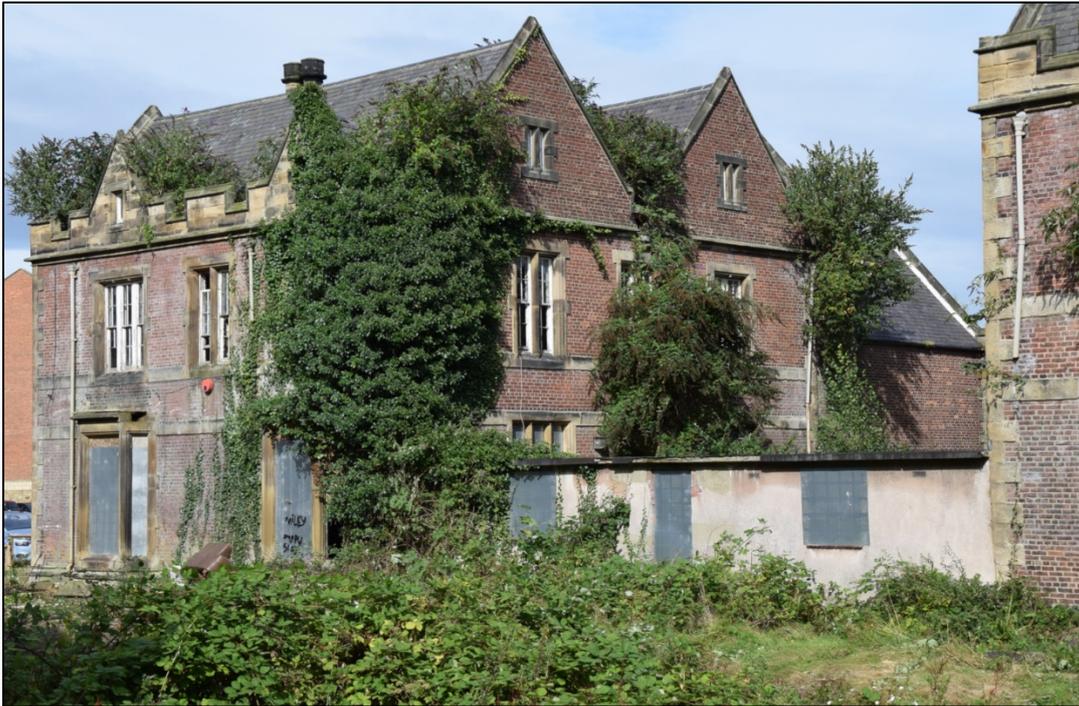
Photograph 9: The 20th-century corridor between the two houses replaced a curved wall with gates at either end. A view looking north-west

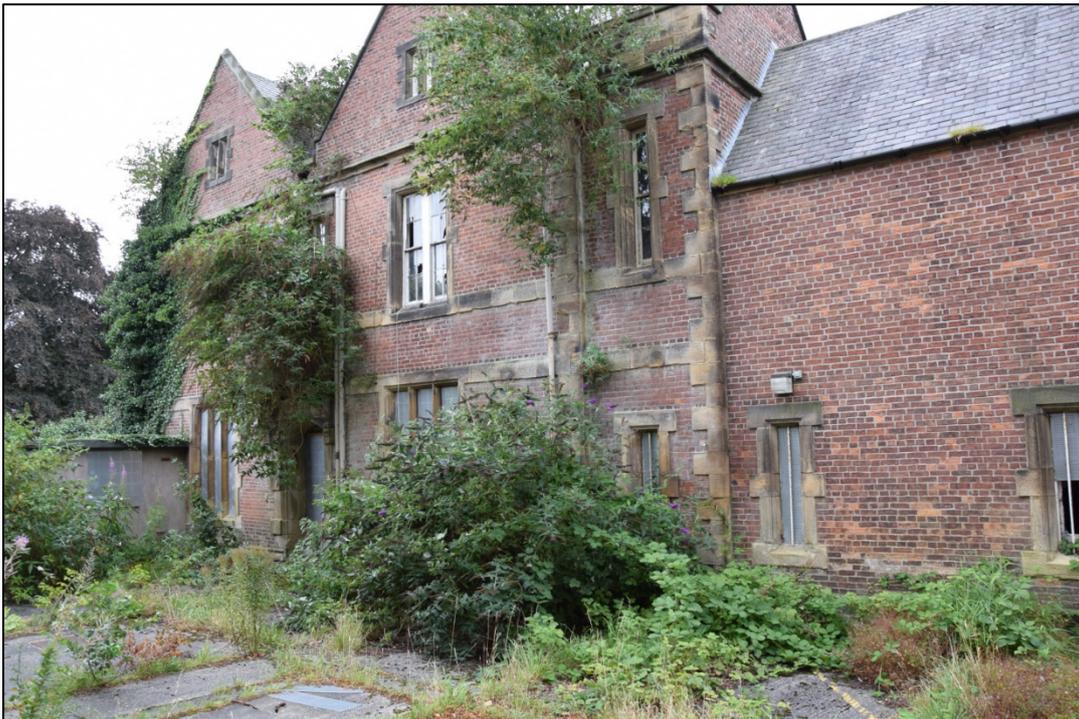
Photograph 10: The east face of Beechfield. The main entrance is left of centre. There are no first-floor windows in the service wing at the right

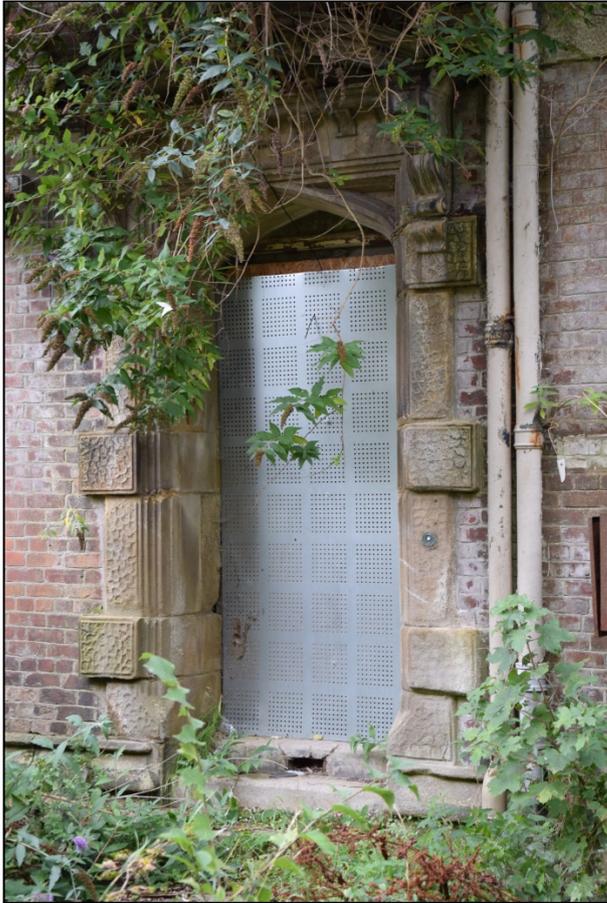
Photograph 11 (left): The front door of Beechfield

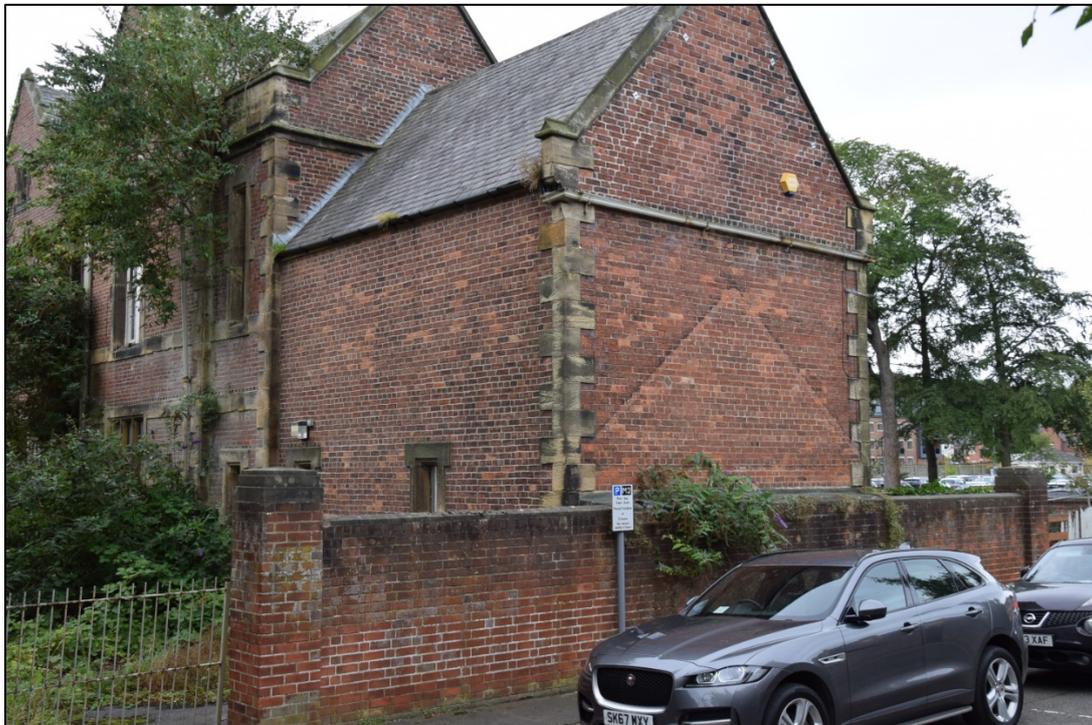
Photograph 12 (below): The service wing at the rear has the mark of a pitched roof for a vanished shed

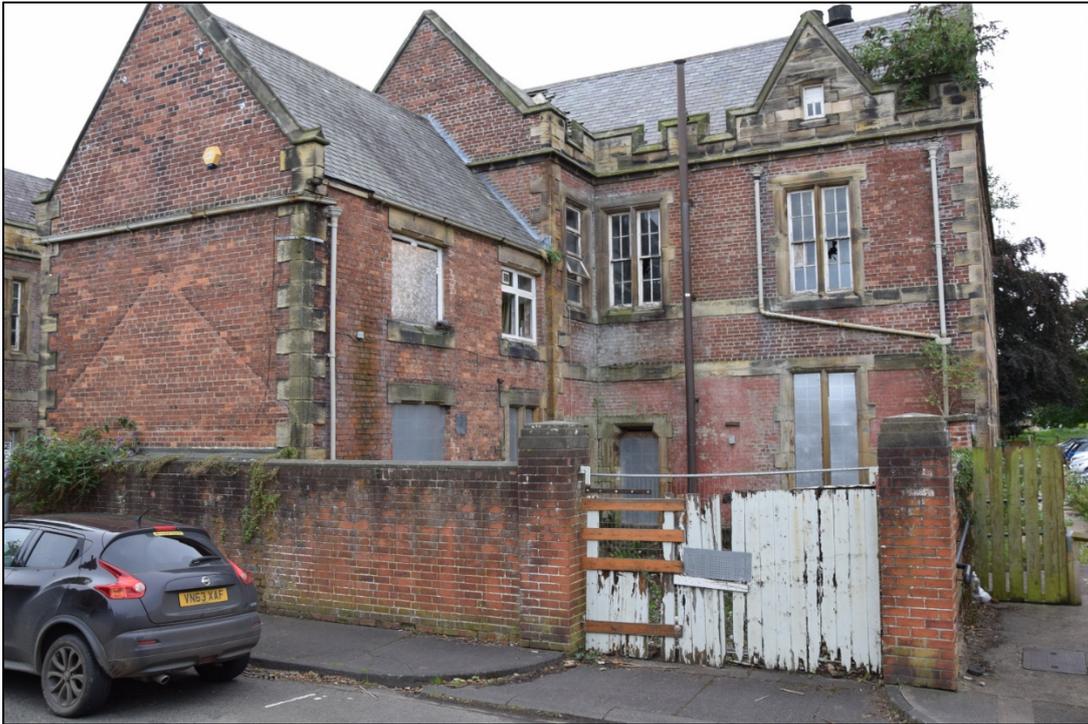
Photograph 13 (above): The service yard at Beechfield. The brick wall seen here and in the previous photograph is a 20th-century addition

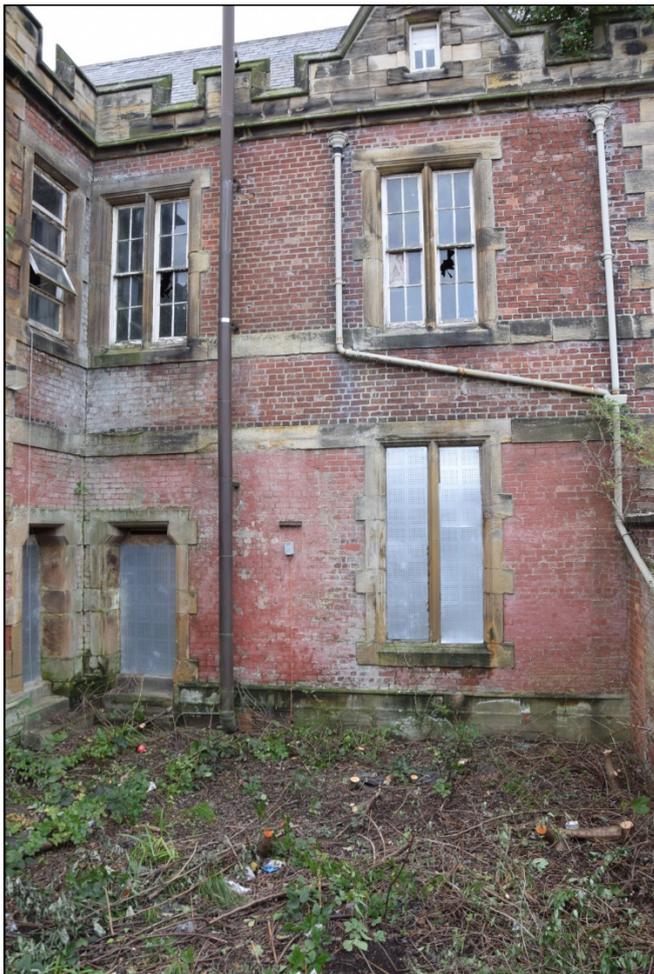
Photograph 14 (left): The north wall and the yard

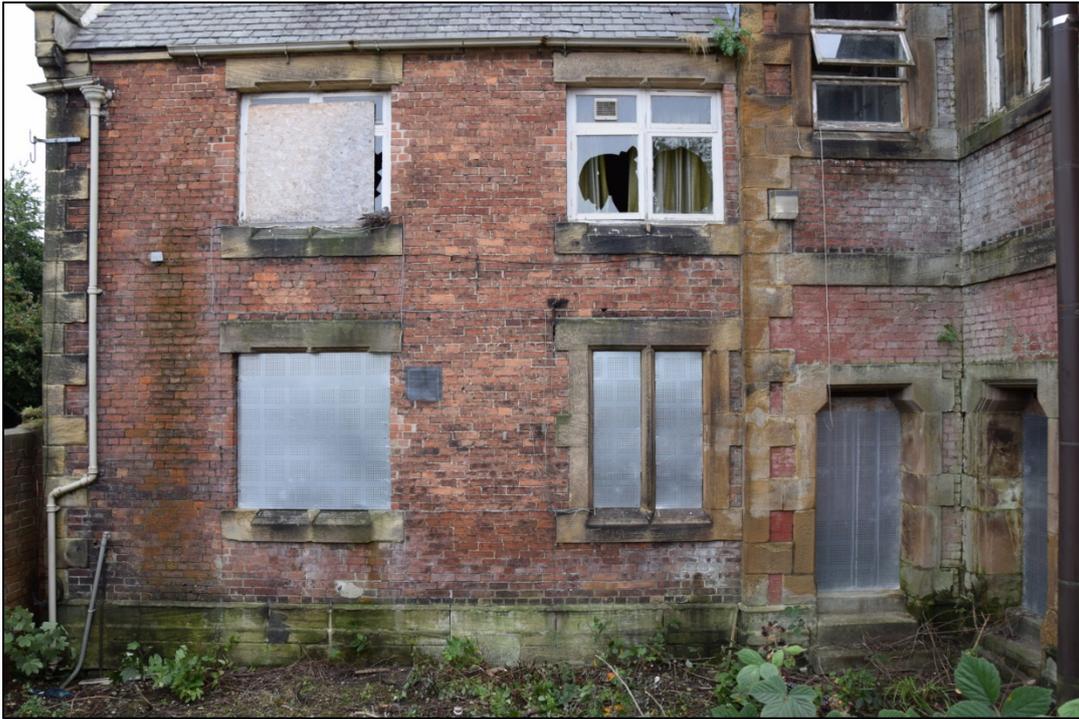
Photograph 15: The east side of the service yard; note the difference in the treatment of the windows

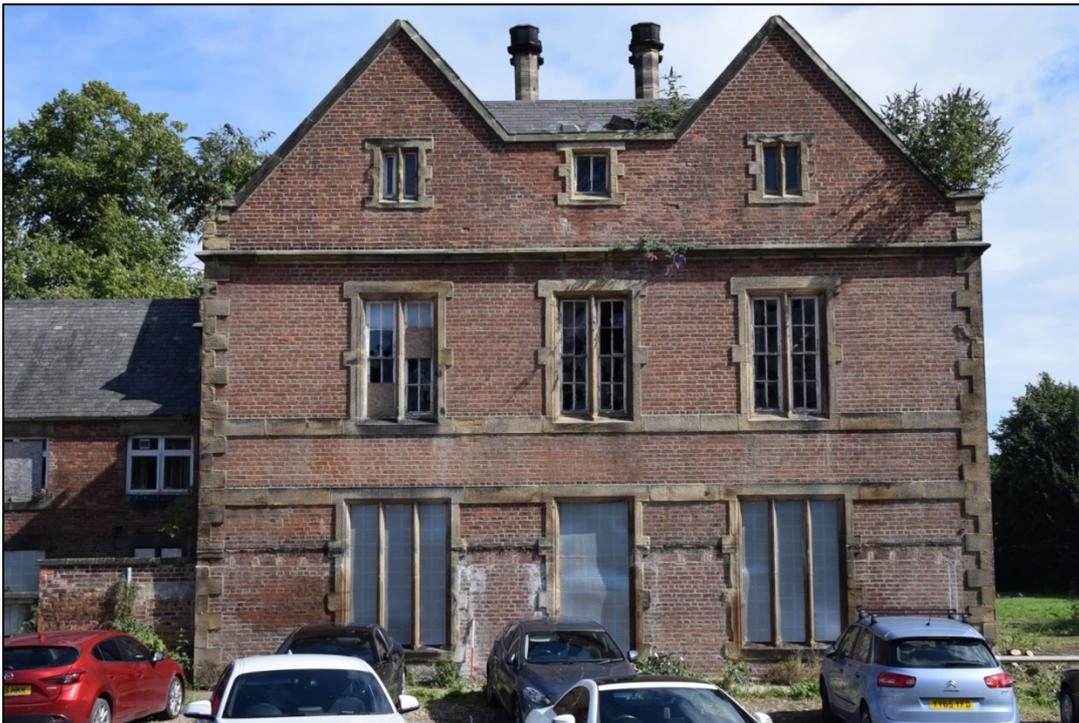
Photograph 16: The west face of Beechfield

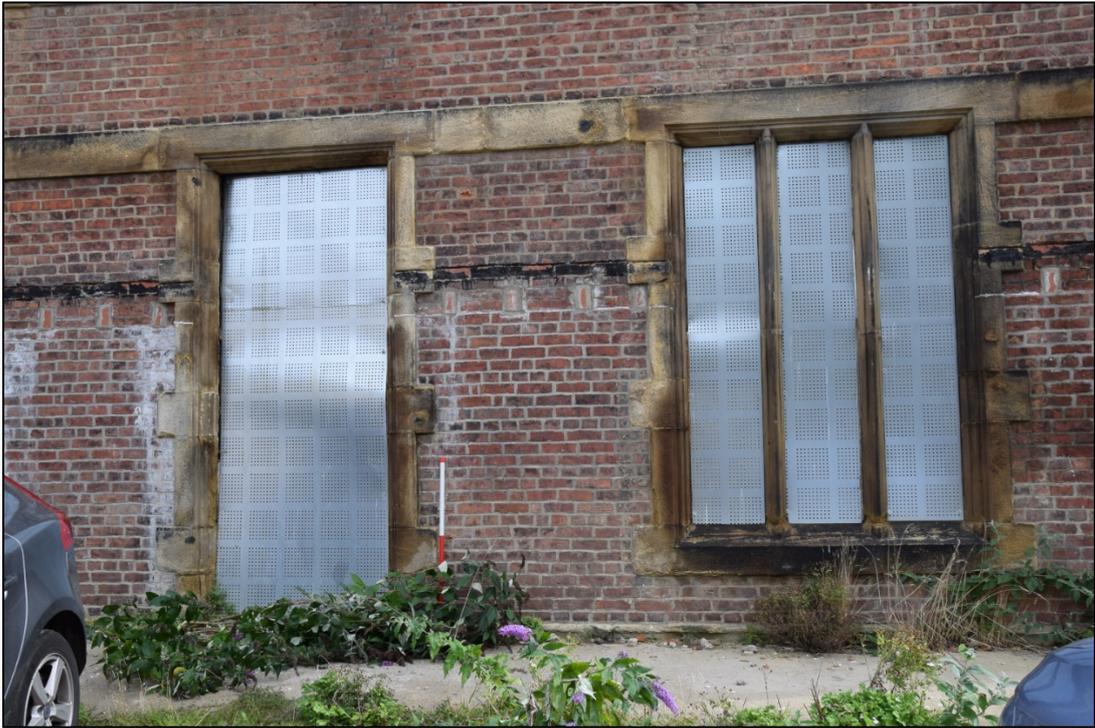
Photograph 17: The central door in Beechfield's west wall. Note the black roof scar and the joist sockets from the 1960s library

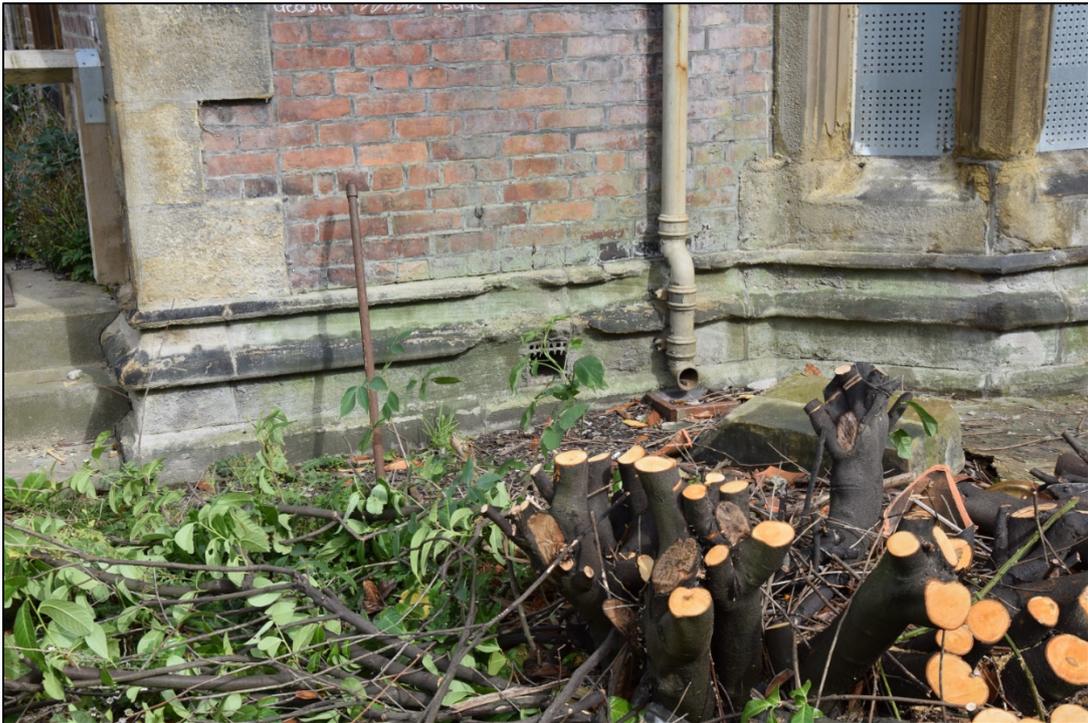
Photograph 18: The moulded plinth at the south-west corner of the house

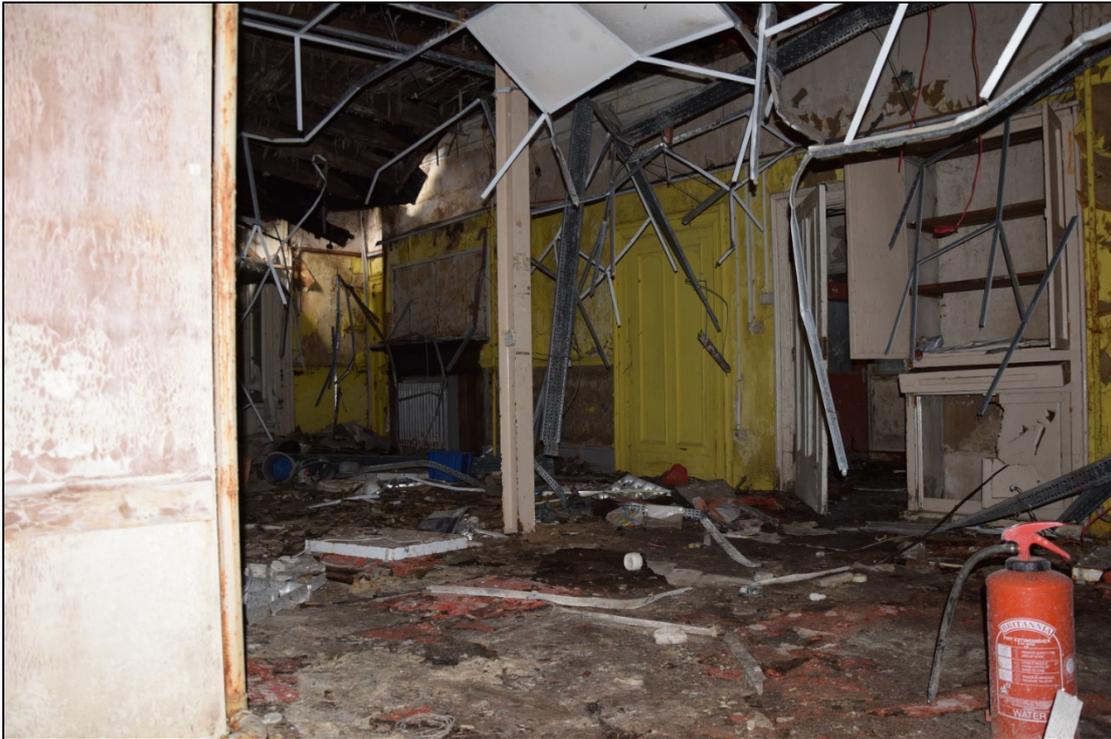
Photograph 19: The former dining and drawing rooms at Beechfield, seen from the south-east

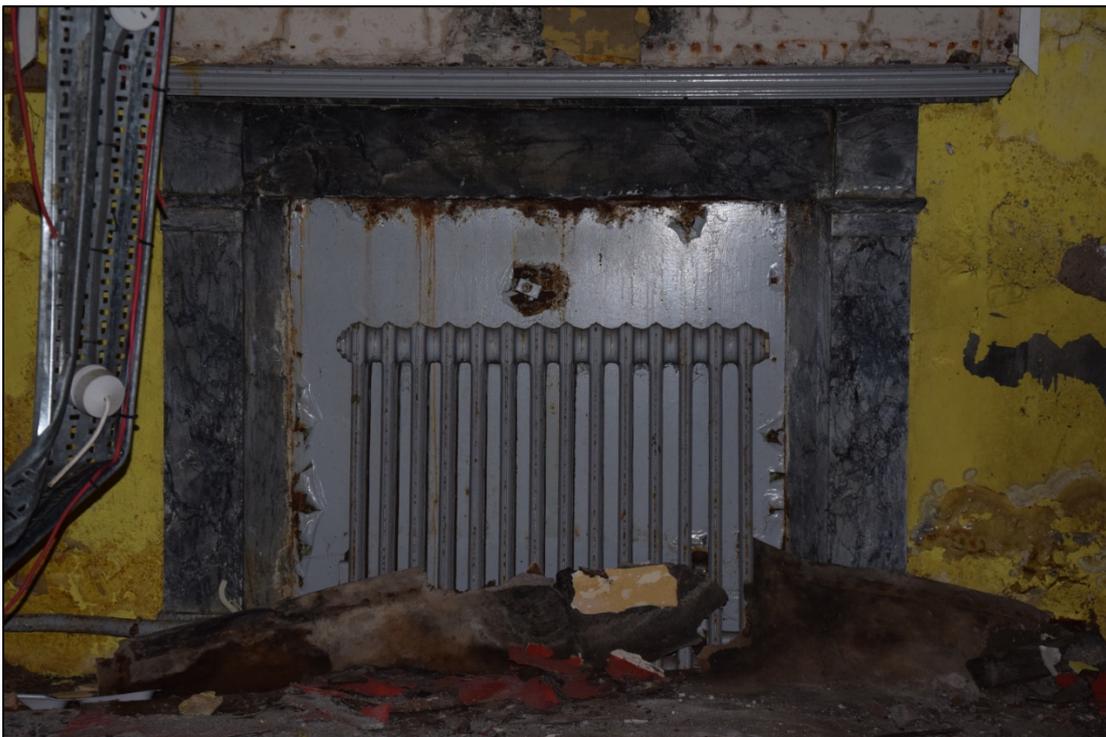
Photograph 20: The marble fireplace in the former drawing room

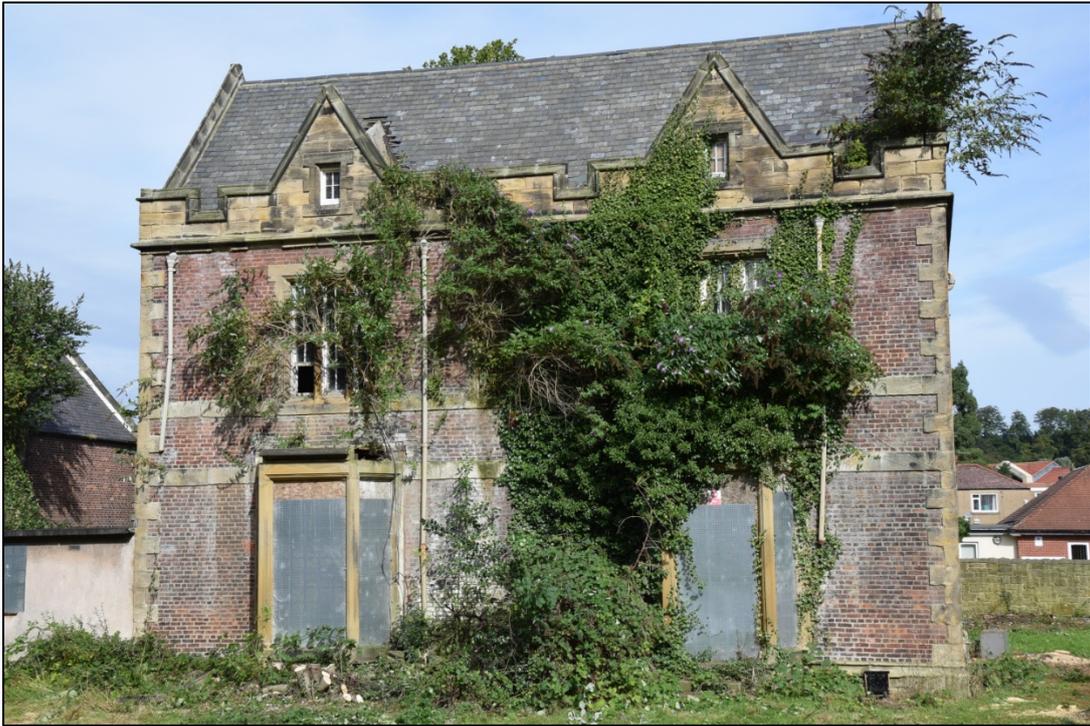
Photograph 21: The south face of The Willows

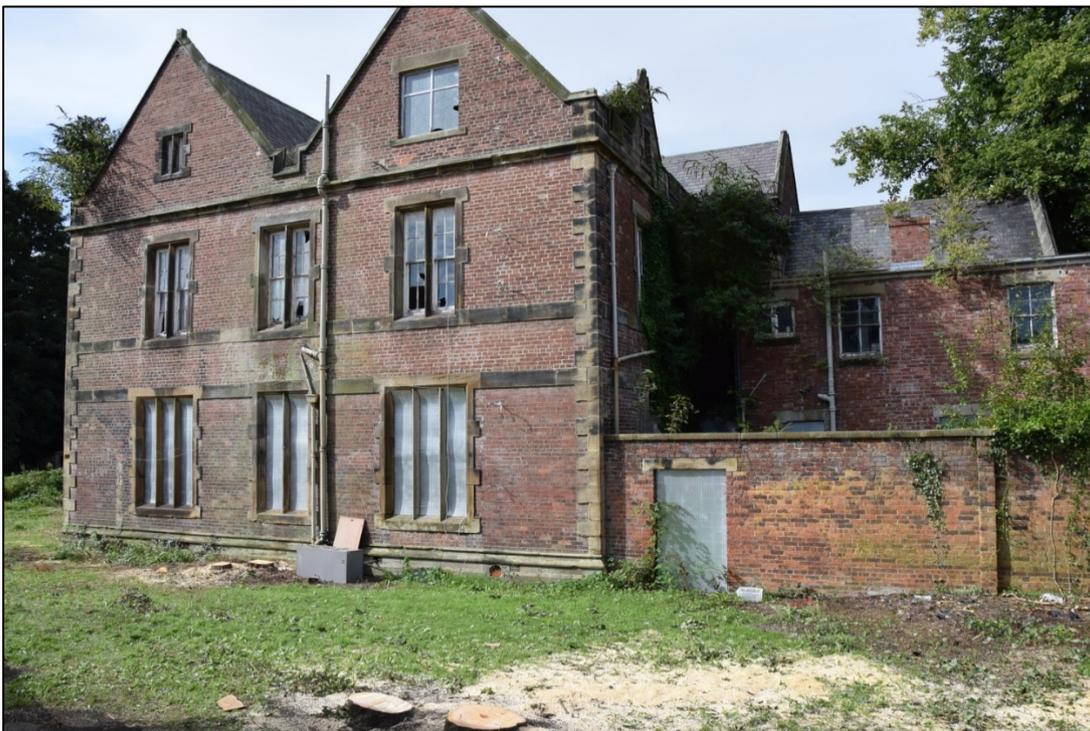
Photograph 22: The east face has no central door, as seen in Photo 17

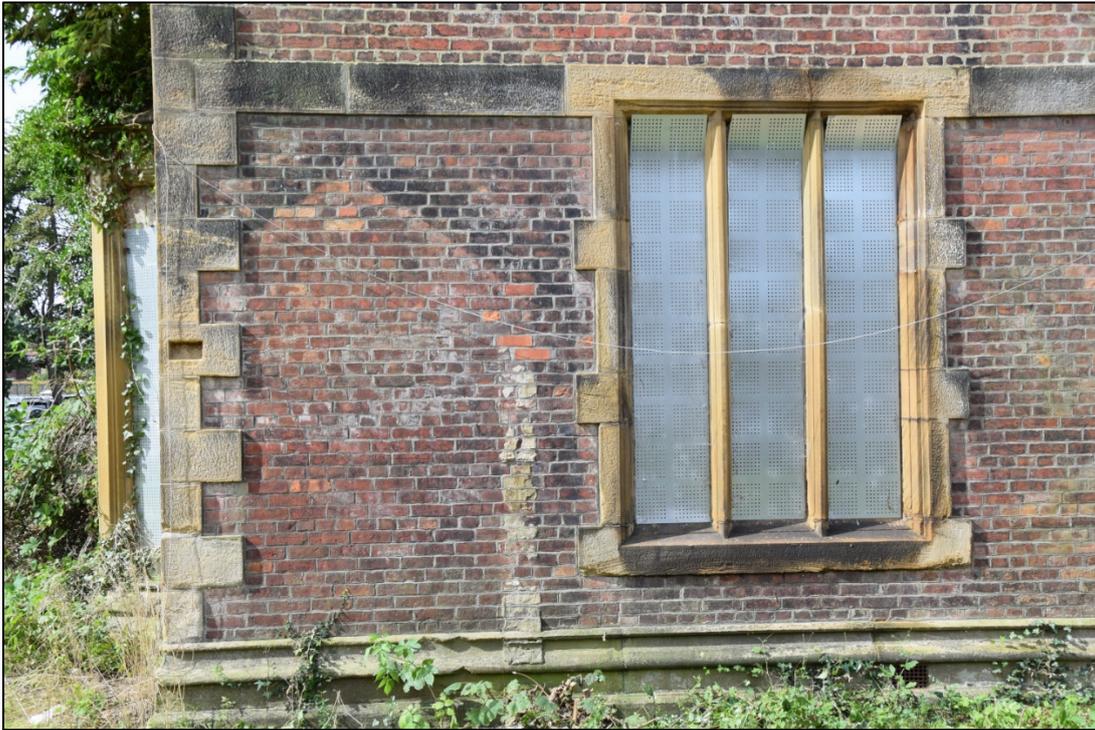
Photograph 23: The outline of the later verandah at the south end of the wall shown above

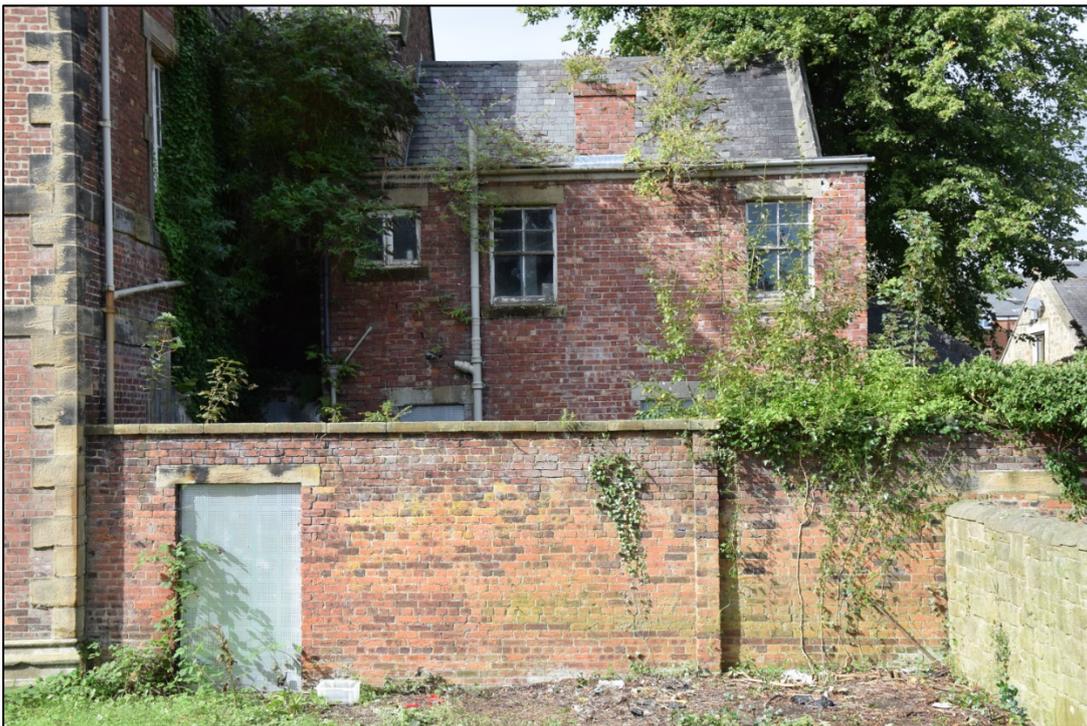
Photograph 24: A 20th-century extension in the service yard at The willows

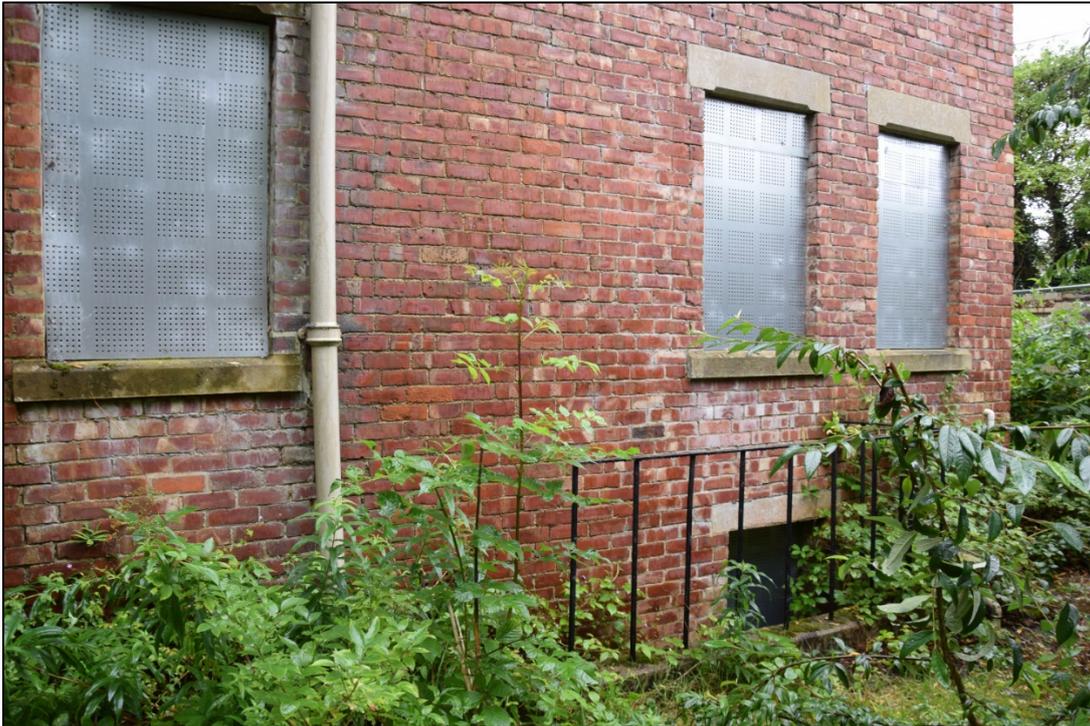
Photograph 25: Steps to a small cellar in the extension

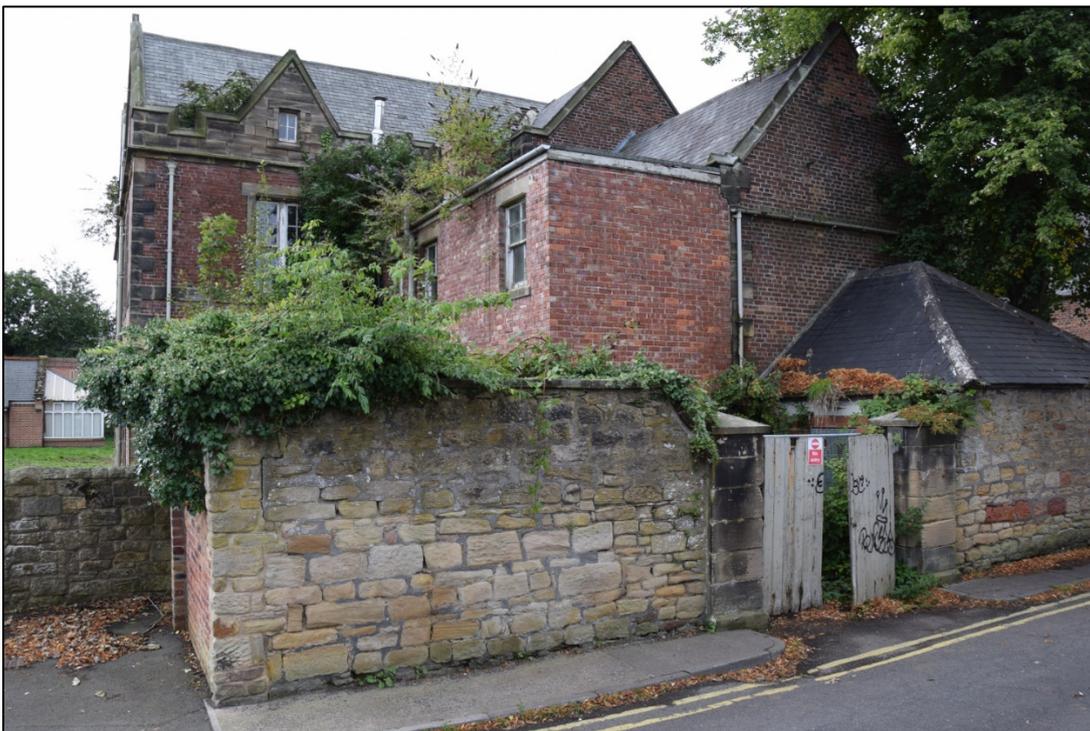
Photograph 26: The service yard at The Willows retains the original boundary wall and stone gate piers

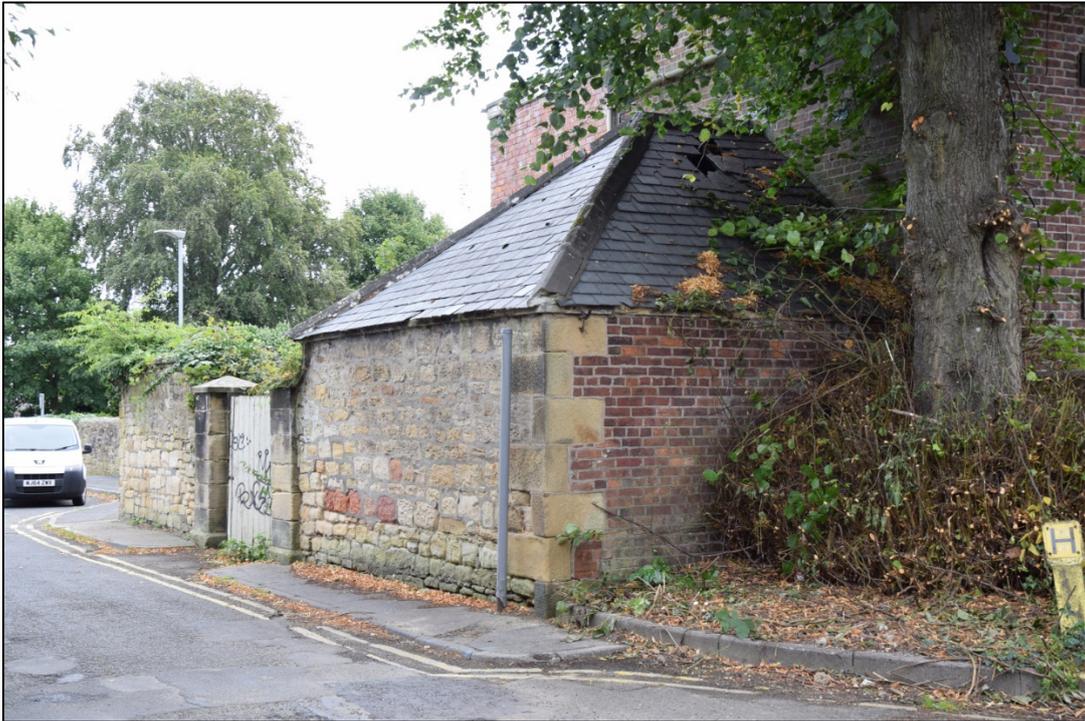
Photograph 27: The stone shed at the north end of the service yard; compare with the wall mark seen in Photo 12

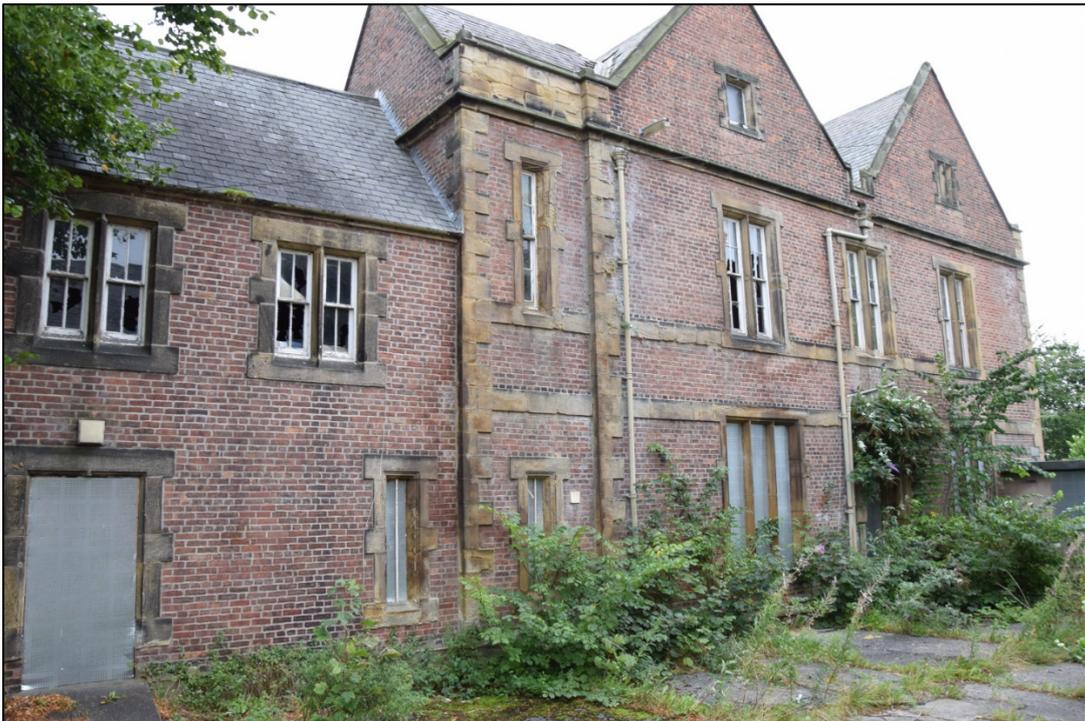
Photograph 28: The west face of The Willows
