ARCHAEOLOGICAL  
SERVICES  
DURHAM UNIVERSITY

Morpeth Leisure Centre  
Morpeth  
Northumberland

archaeological building recording

report 5136  
September 2019

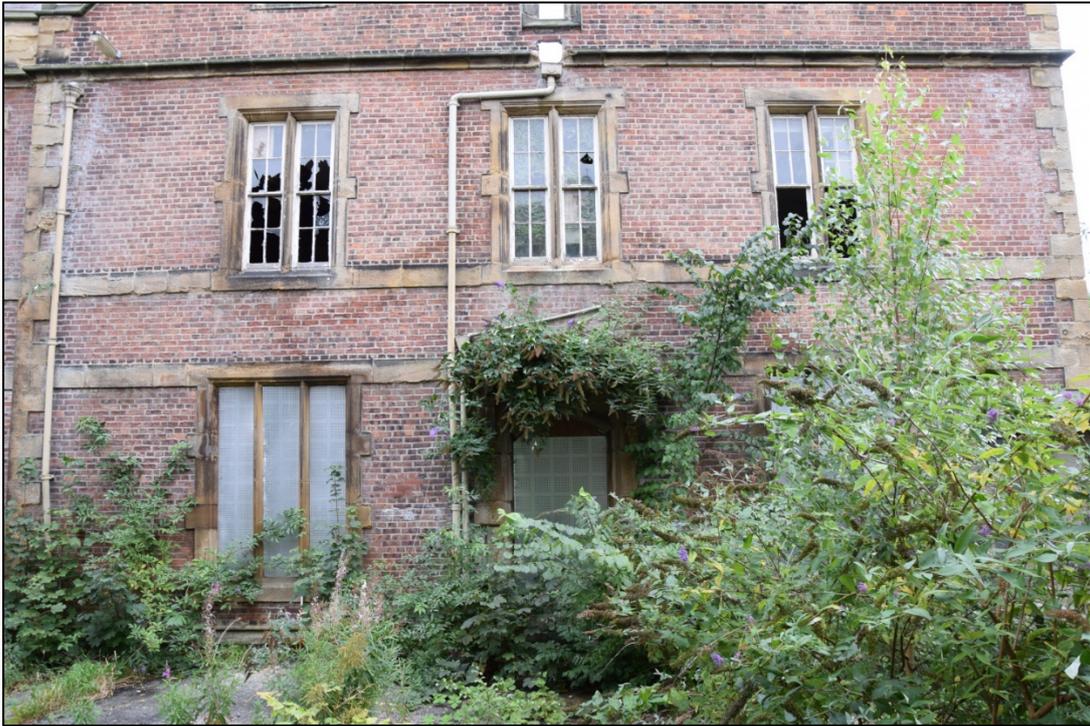
Photograph 29: Bushes and young trees hide the 20th-century corridor and mask the front door

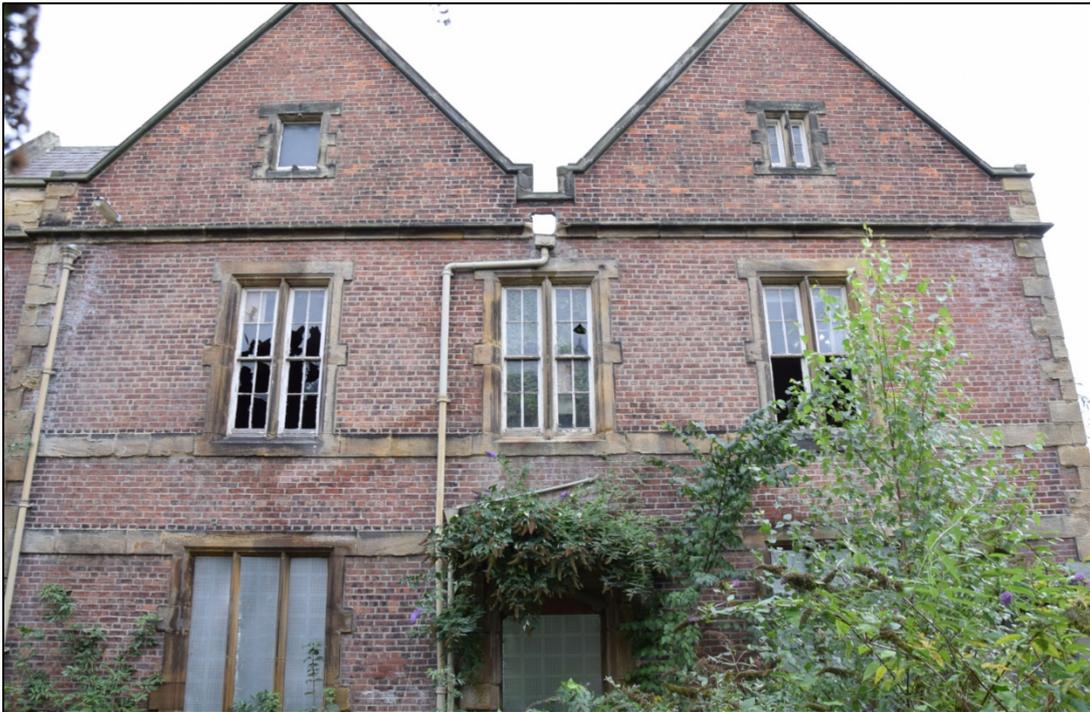
Photograph 30: The upper floors on the west face

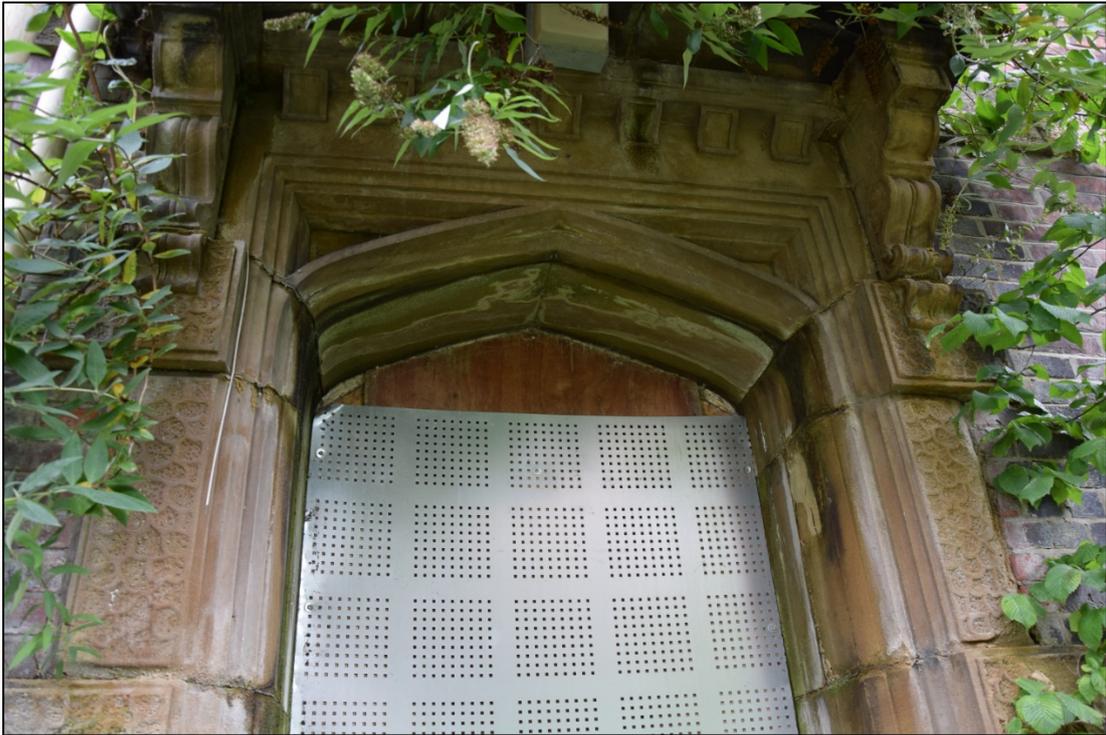
Photograph 31: The front door matches that of the opposite house

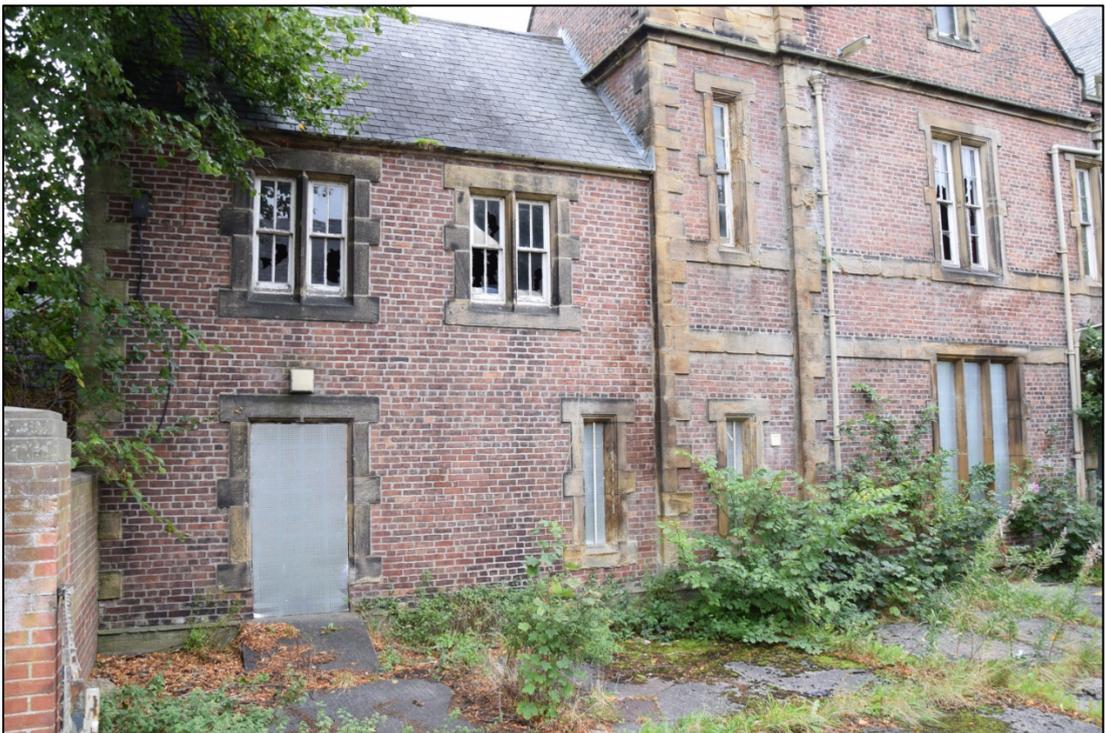
Photograph 32: The service wing is different from its neighbour, opposite
